NEW ZEALAND AIRFIELD PAVEMENT SURFACE TYPES – EVALUATION, DESIGN,
MAINTENANCE AND REHABILITATION

By:
John Marsh and John Cairns
Beca Airports Ltd
132 Vincent Street
Auckland
New Zealand
Phone: (+64) 9 300 9000; Fax: (+64) 9 300 9300
john.marsh@beca.com
john.cairns@beca.com

PRESENTED FOR THE
2010 FAA WORLDWIDE AIRPORT TECHNOLOGY TRANSFER CONFERENCE
Atlantic City, New Jersey, USA

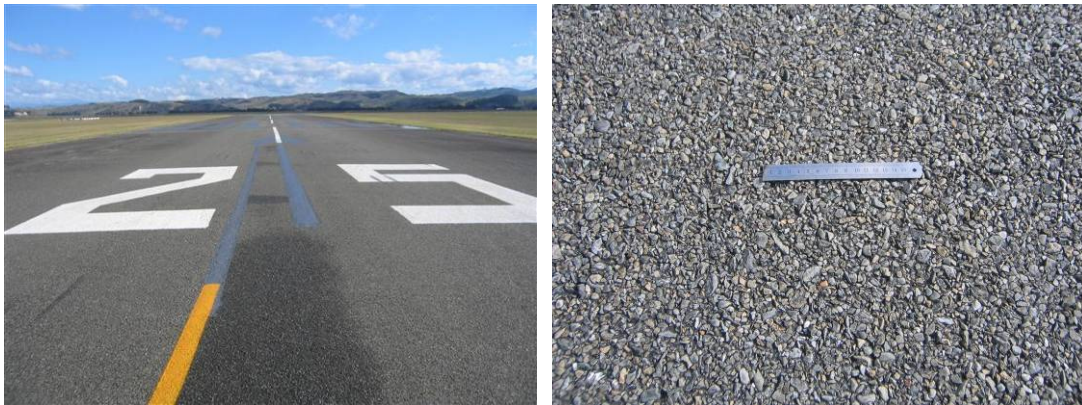
Figure 2 - Hawke’s Bay (Napier) Runway 07-25 - Chip Seal Surface

Chipseal Pavements – historically one of the more common pavement surface types around the regional airport network in New Zealand. The flexible aggregate pavement basecourses are sprayed with a bituminous prime coat before typically two coats of “chipseal” are applied. The chip is typically graded from 5 to 20mm and a tightly packed surfacing layer is formed for trafficking. This is an example of “roading” type pavements being adapted for light duty aircraft as an economic airfield surfacing and was originally used on a number of airfields in New Zealand. Currently, this is only likely to be used by turboprop type aircraft, and surface details are shown below from Hawke’s Bay (Napier) Runway 07-25 (refer to Figure 2).

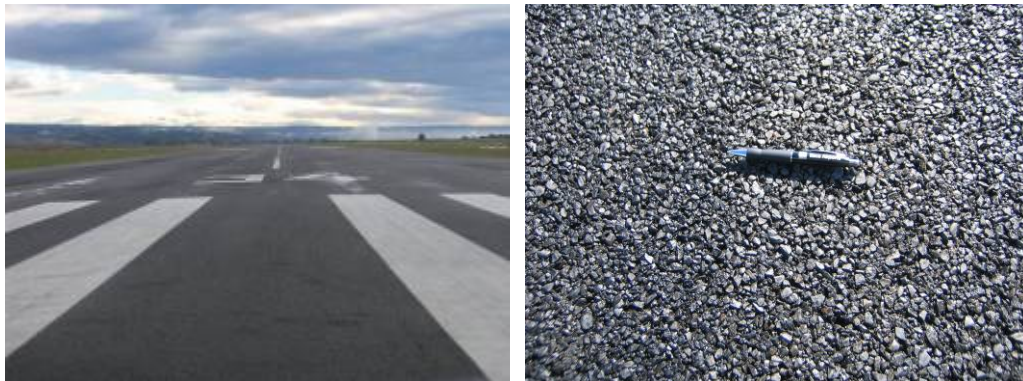
Figure 3 - Hawke's Bay (Napier) - Runway 16-34 – OGPA Surface

OGPA surface details are shown below from Hawke's Bay (Napier) Runway 16-34 (refer to Figure 3). Stone Mastic Asphalt has not been used to date on airfield pavements in New Zealand.

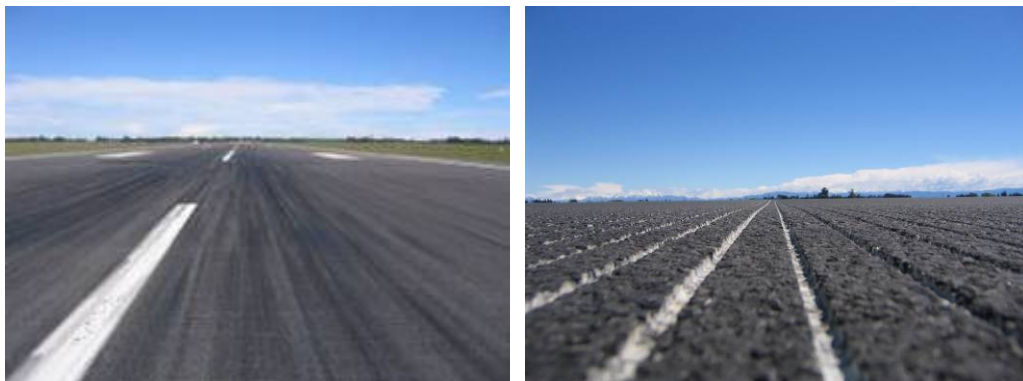
Figure 4 - Christchurch International Airport - Runway 02-20 - Grooved Asphalt Surface

Many variations of AC are to be found around the airfields in New Zealand, including conventional dense graded asphalt, grooved asphalt, variations of Superpave asphalt and Open Graded Porous Asphalt (OGPA) or Porous Friction Course. Dense graded asphalts are typically used at most major airports with Christchurch International Airport (Runway 02-20) and Wellington International Airport (Runway 16-34) having the only grooved runways. Elsewhere it has been found that the AC grading adopted has achieved the NZ CAA Advisory Circular AC139-13 (Reference 1) and ICAO Annex 14 Design Level friction values without grooving. Where adopted the grooving pattern is 6mm wide by 6mm deep at 38mm centres.

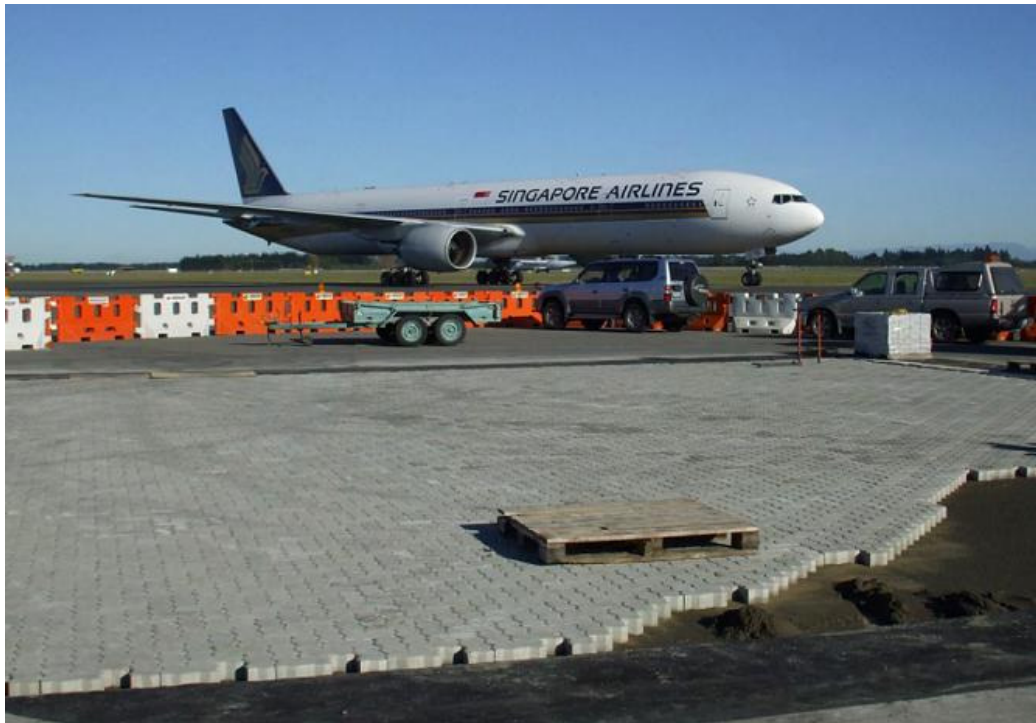
Figure 5 - Christchurch International Airport - ICBP Under Construction

Interlocking Concrete Block Pavements – over the last few years the use of Interlocking Concrete Block Pavements (ICBP) on airfields in New Zealand has progressed as an economical alternative to PCC pavements. To date this has been limited to use at aircraft parking stands at Christchurch International Airport (International Stand 27 and Stand 34/35). The blocks have been laid on a 20mm thick layer of bedding sand on a cement stabilised basecourse layer with the blocks being sealed. To date the pavements are performing well under loading from Code E derivative aircraft.

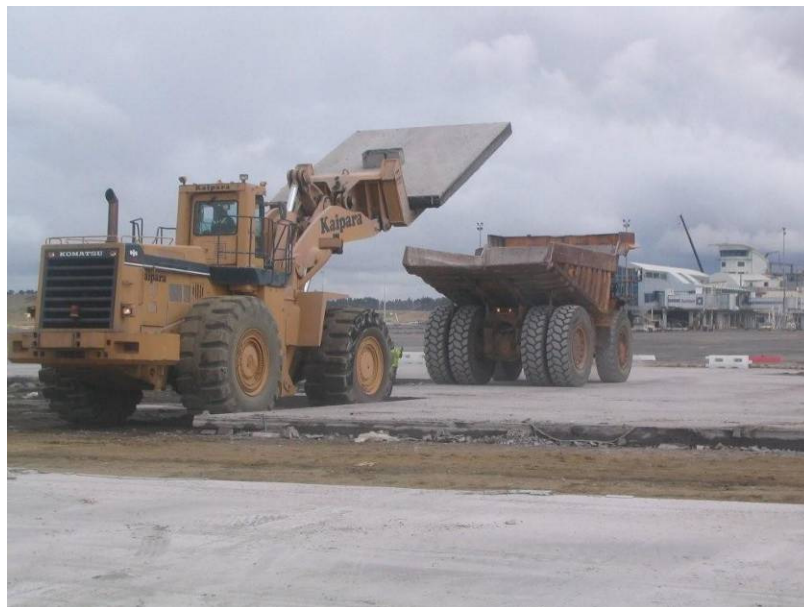
Figure 6 – Concrete Slab Removal with Modified Mining Equipment at Auckland Airport

Specialist plant and equipment is not always available in a ‘small’ country such as New Zealand at the end of the world. For example some large gantry equipment common for concrete slab removal can not be justified for a single concrete pavement network at Auckland Airport, so new methodologies have had to be developed. This has included modifying large mining construction plant with custom forks and using these overgrown forklifts to lift and remove the concrete slabs as shown in Figure 6.

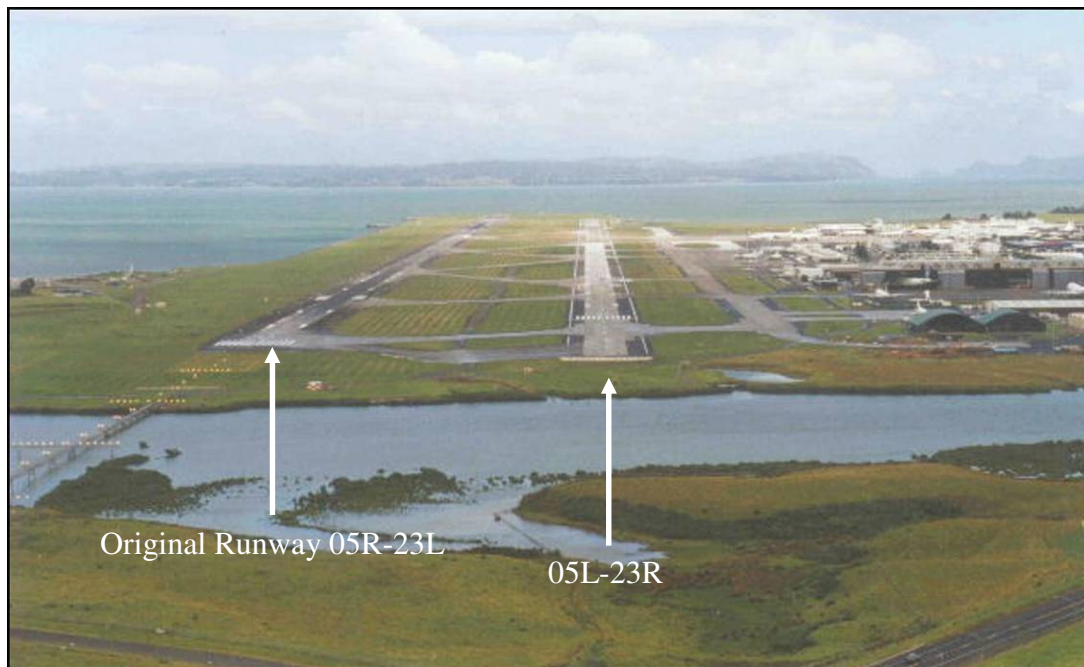
Figure 10. The Completed Temporary Runway 05L-23R

Alternative solutions to replace the central runway sections were studied and the concept of converting the airport's parallel runway into a fully functional temporary runway was developed. Constructed through 2000 and 2001, the project involved the following scope of works: the parallel taxiway was strengthened and widened from 23m to 45m; additional inner parallel taxiways were constructed to provide access to the ends of the new temporary runway; a new approach lighting system was constructed and runway lighting and marking applied to the taxiway.

The stand-by Runway 05L-23R was first used in April 2002 for the R3 Reconstruction Project. All airport operations were diverted to the temporary runway for a period of 23 days and the original runway closed for reconstruction. The project was considered to be a huge success and was noted by the airport to be the longest use of a stand-by runway in the southern hemisphere, if not the world. The temporary runway was used again each year until the runway reconstruction was completed in 2006.

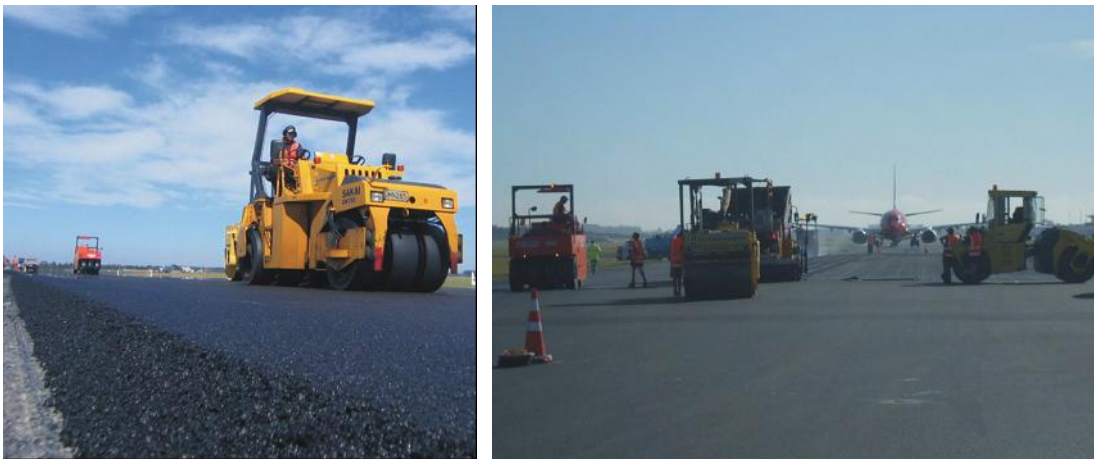
Figure 11 - Christchurch International Airport – Taxiway A Asphalt Works

- Resurfacing the full width of the main parallel taxiway, Taxiway A with asphalt (AC14 Mix) ranging in thickness from 50 to 115mm. Lengths of the shoulders and a 50m long section of the taxiway have been resurfaced with asphalt mixes containing 15% Recycled Asphalt Pavement (RAP). A 150 tonne trial using Coolpave Warm Mix asphalt was also undertaken on Taxiway A in 2008.

One of the innovations adopted in 2008 was the use of Recycled Asphalt Pavement (RAP) in the asphaltic concrete on Taxiway A. Approximately 2,000 tonnes of asphalt with RAP at replacement level of 15% was used on the shoulders of and on a limited trial over the full width of the taxiway. This resulted in the saving of approximately 300 tonnes of new aggregates and bitumen. Whilst there are additional costs in the slightly higher production temperatures and in transporting the asphalt millings from the airport to the mixing plant, an approximate saving of the order of NZ\$10,000 was achieved on the 2008 project. In both 2009 and 2010, with growing confidence in the use of RAP, areas of pavements have been laid with RAP levels up to 30%. Further laboratory testing will be undertaken to explore the use of RAP levels of 50 to 90% over the next two years. The use of RAP on airfield pavements in both New Zealand has been limited to date and the works at Christchurch International Airport are presently leading the way.
